Memorandum

Date: *August 15, 2014*

Subject: *Oversight Summary Report
CPG Oversight of RM 10.9 Removal Action
Lower Passaic River Restoration Project*

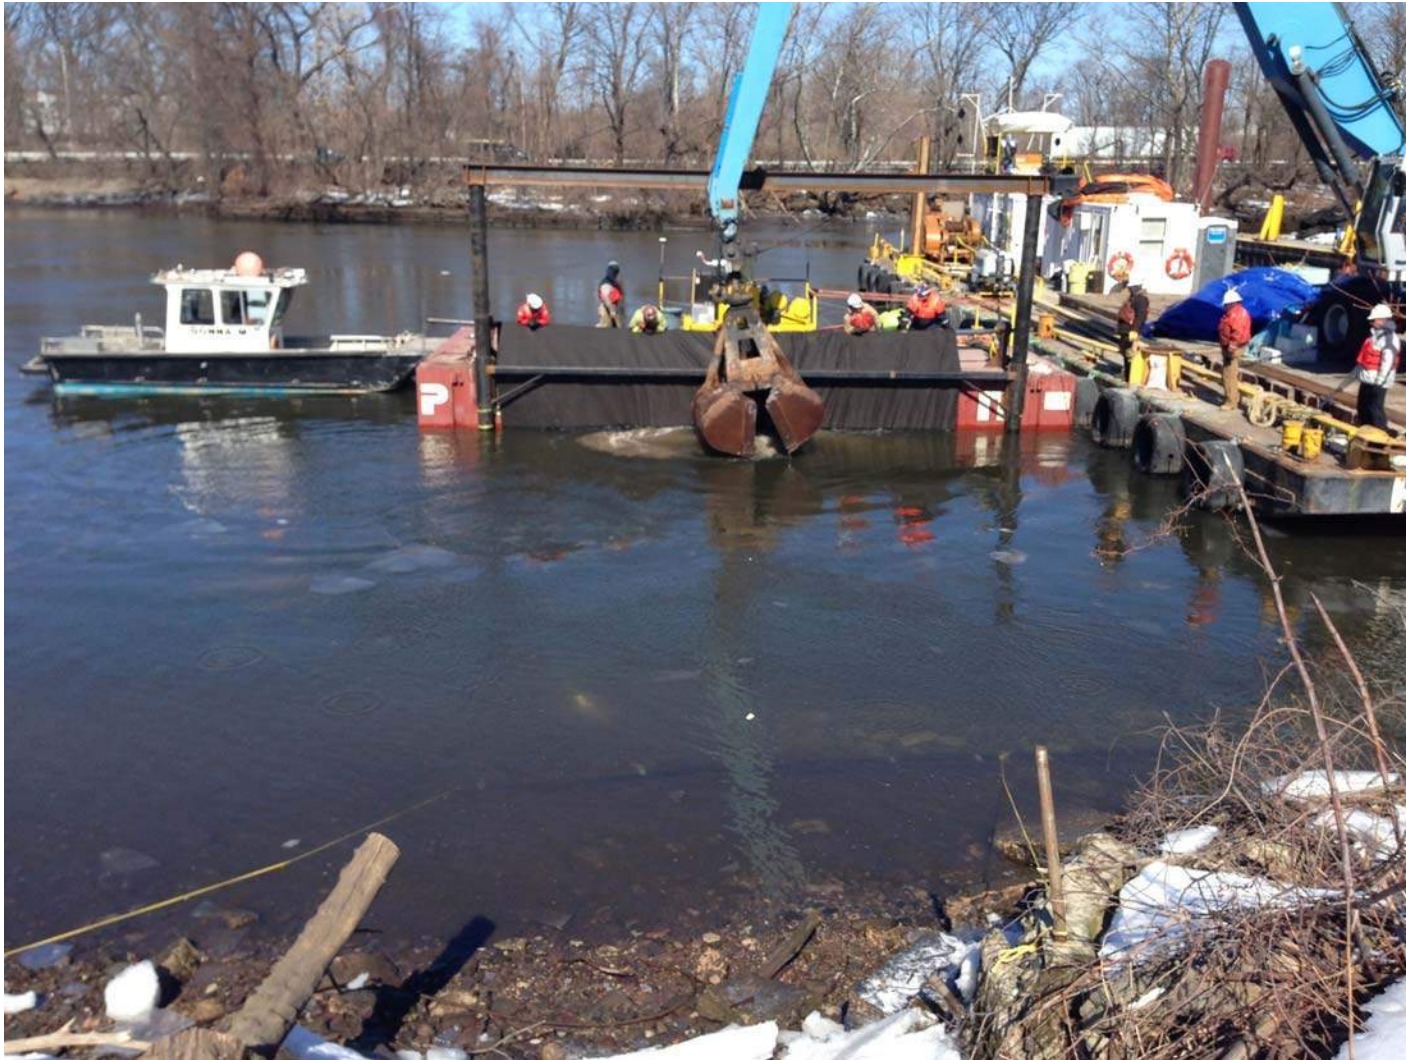
Submerged Geotextile

In this photograph the water is relatively shallow, and as a result the installed geotextile fabric is visible. It is relatively flat beneath the armor stone. The panel shown here is about 75% installed (i.e., there's another 15-20 feet to go).

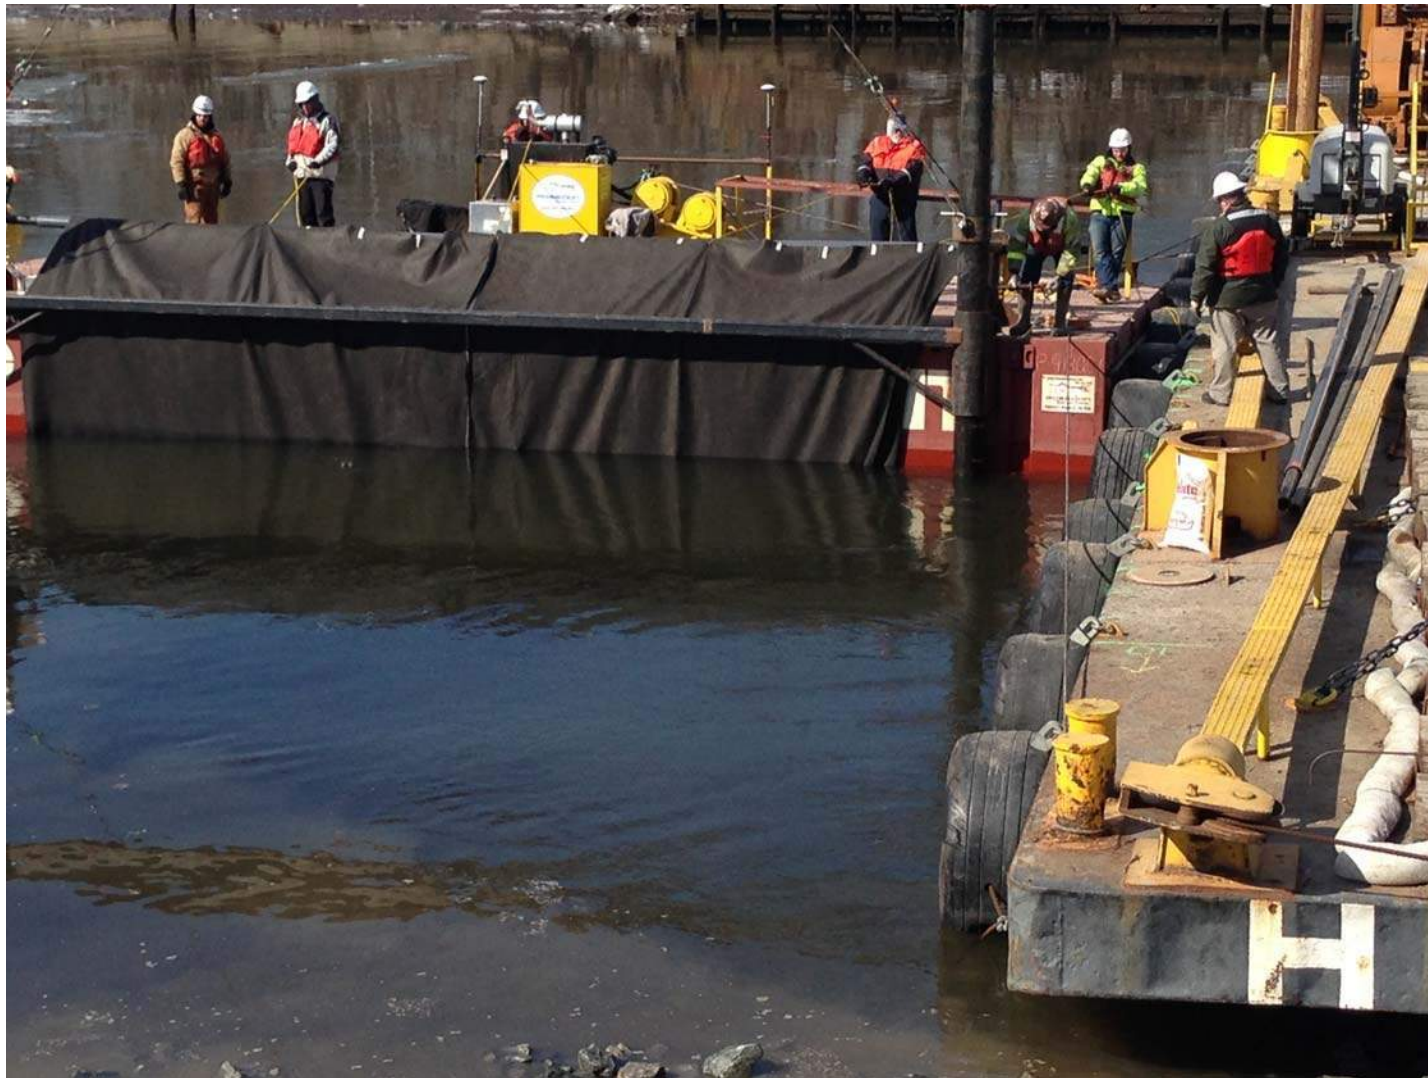
Influence of Current on Geotextile Installation

While the sinking bar assembly has mitigated most of the effects of the current, the above photo shows how the northern edge of the fabric continues to fold slightly. GLDD addressed this by threading ropes through the edge of the fabric and holding them from the barge.

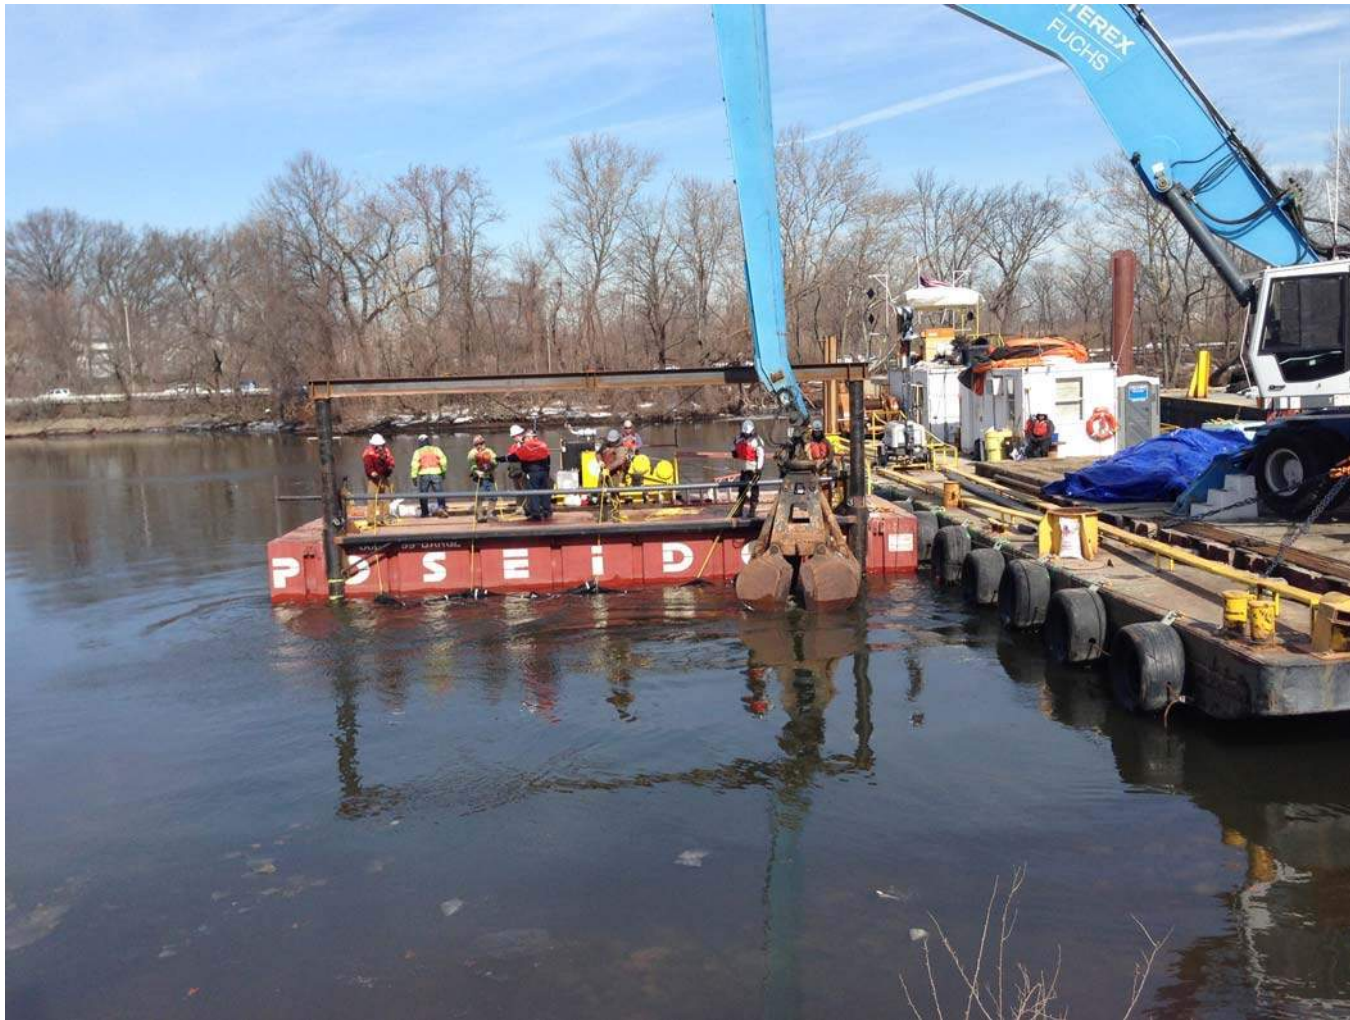
End of Panel Installation

Once almost all of the panel has been submerged and anchored, the remaining few feet are unspooled and lowered by the workers, as shown above. This is a minor H&S concern, as it introduces the possibility of somebody being pulled forward, but realistically it will not be a problem if nobody has the rope wound around his hand/wrist.

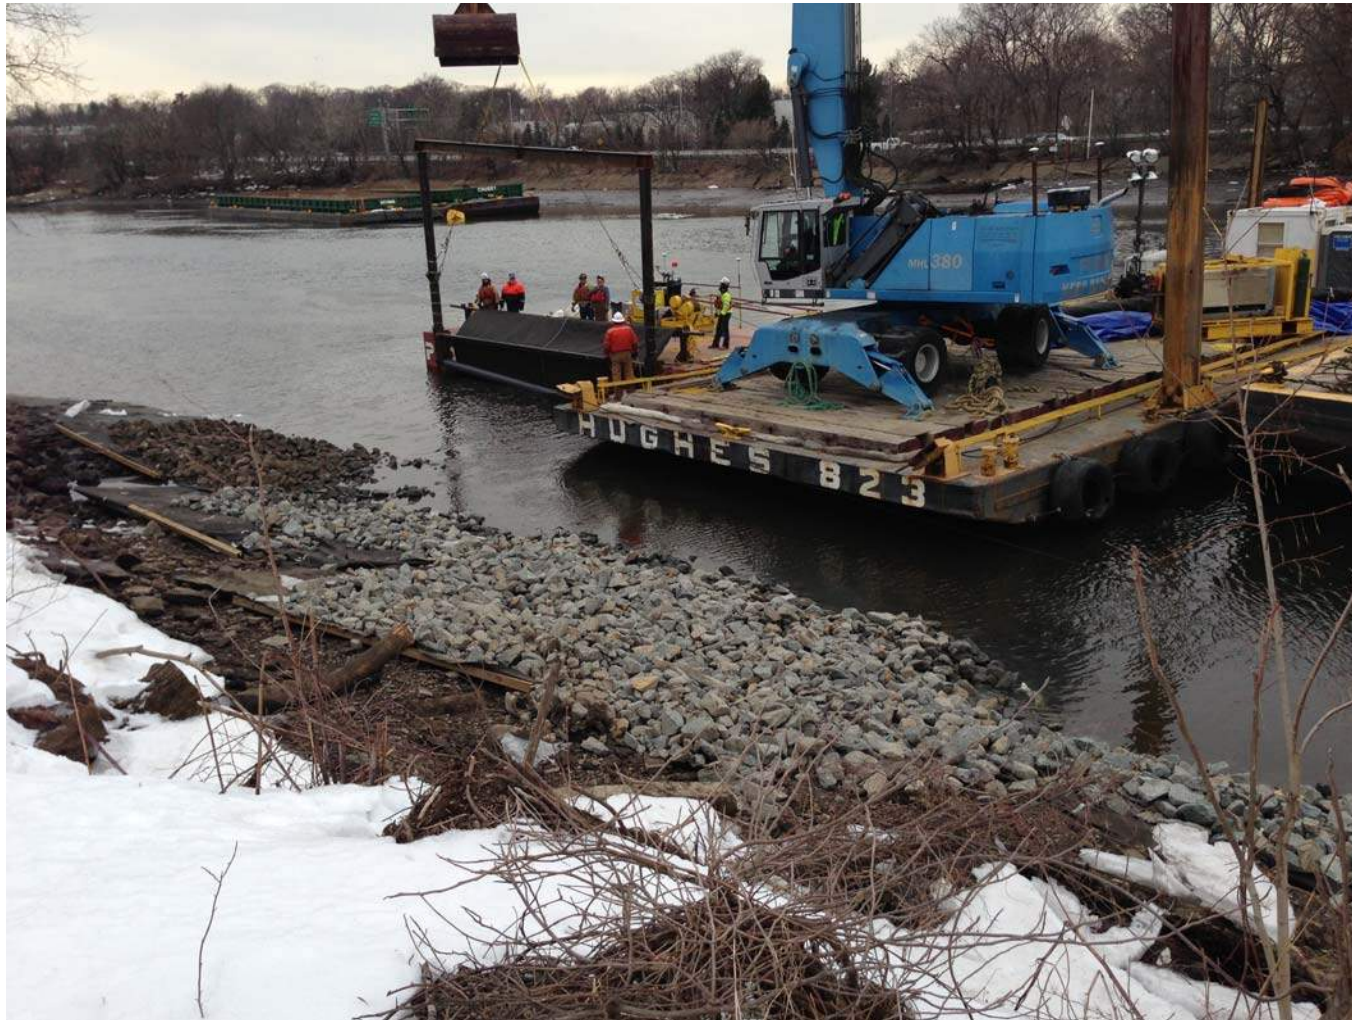
Completed Geotextile Panels

The above photograph includes four completed geotextile panels, three of which were installed today. At the far right is yesterday's panel. The panels typically overlap by about three feet.

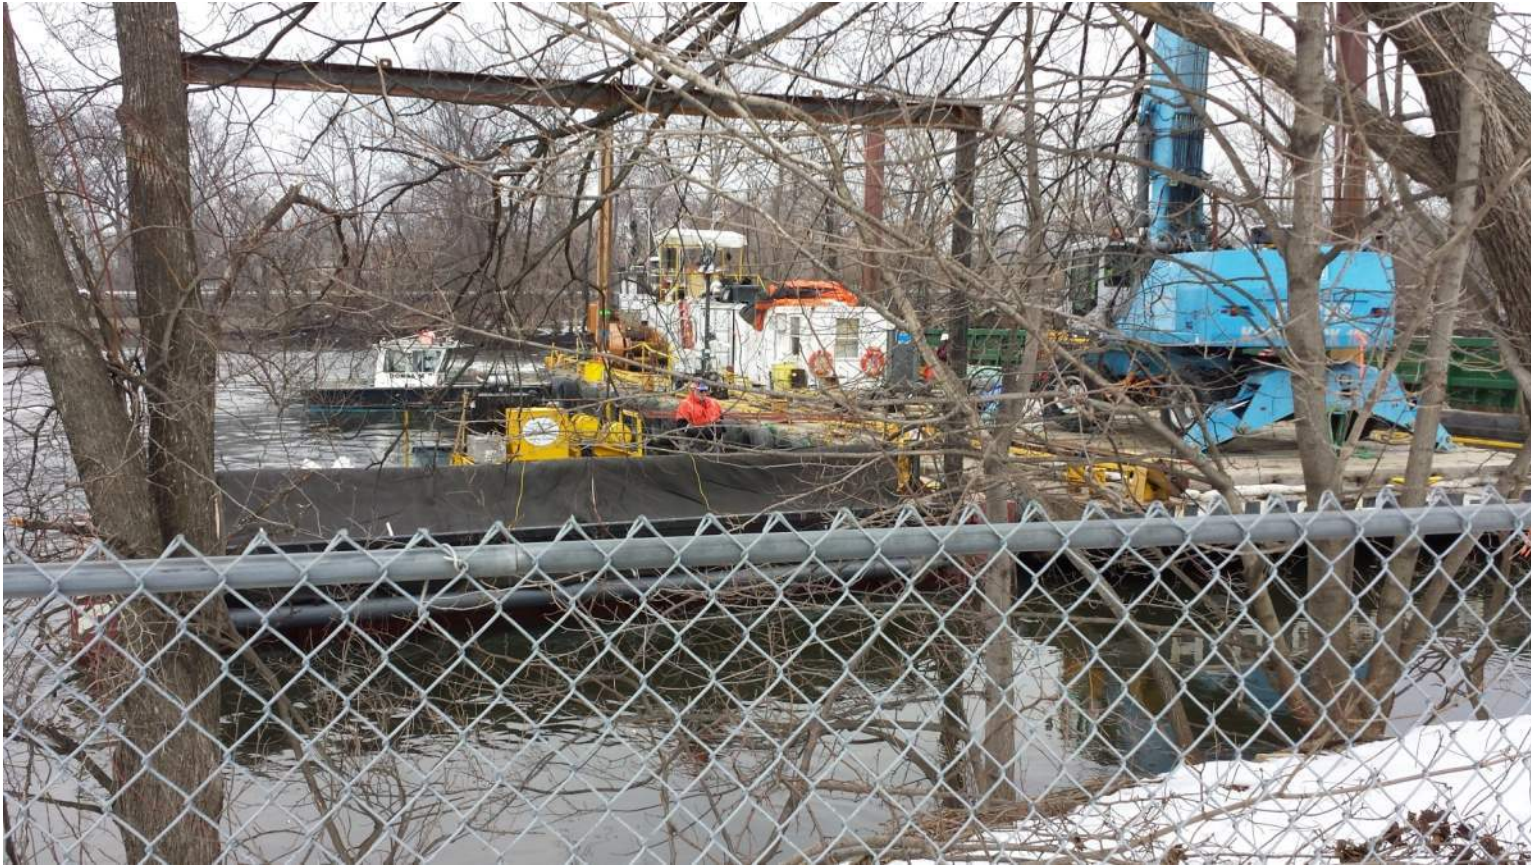
Storm water Outfall

Stormwater outfall located next to current work area. Stan has tried to talk to the town engineer about timing when the outfall ejects water to ensure that it doesn't impact any of the work being completed on the river.

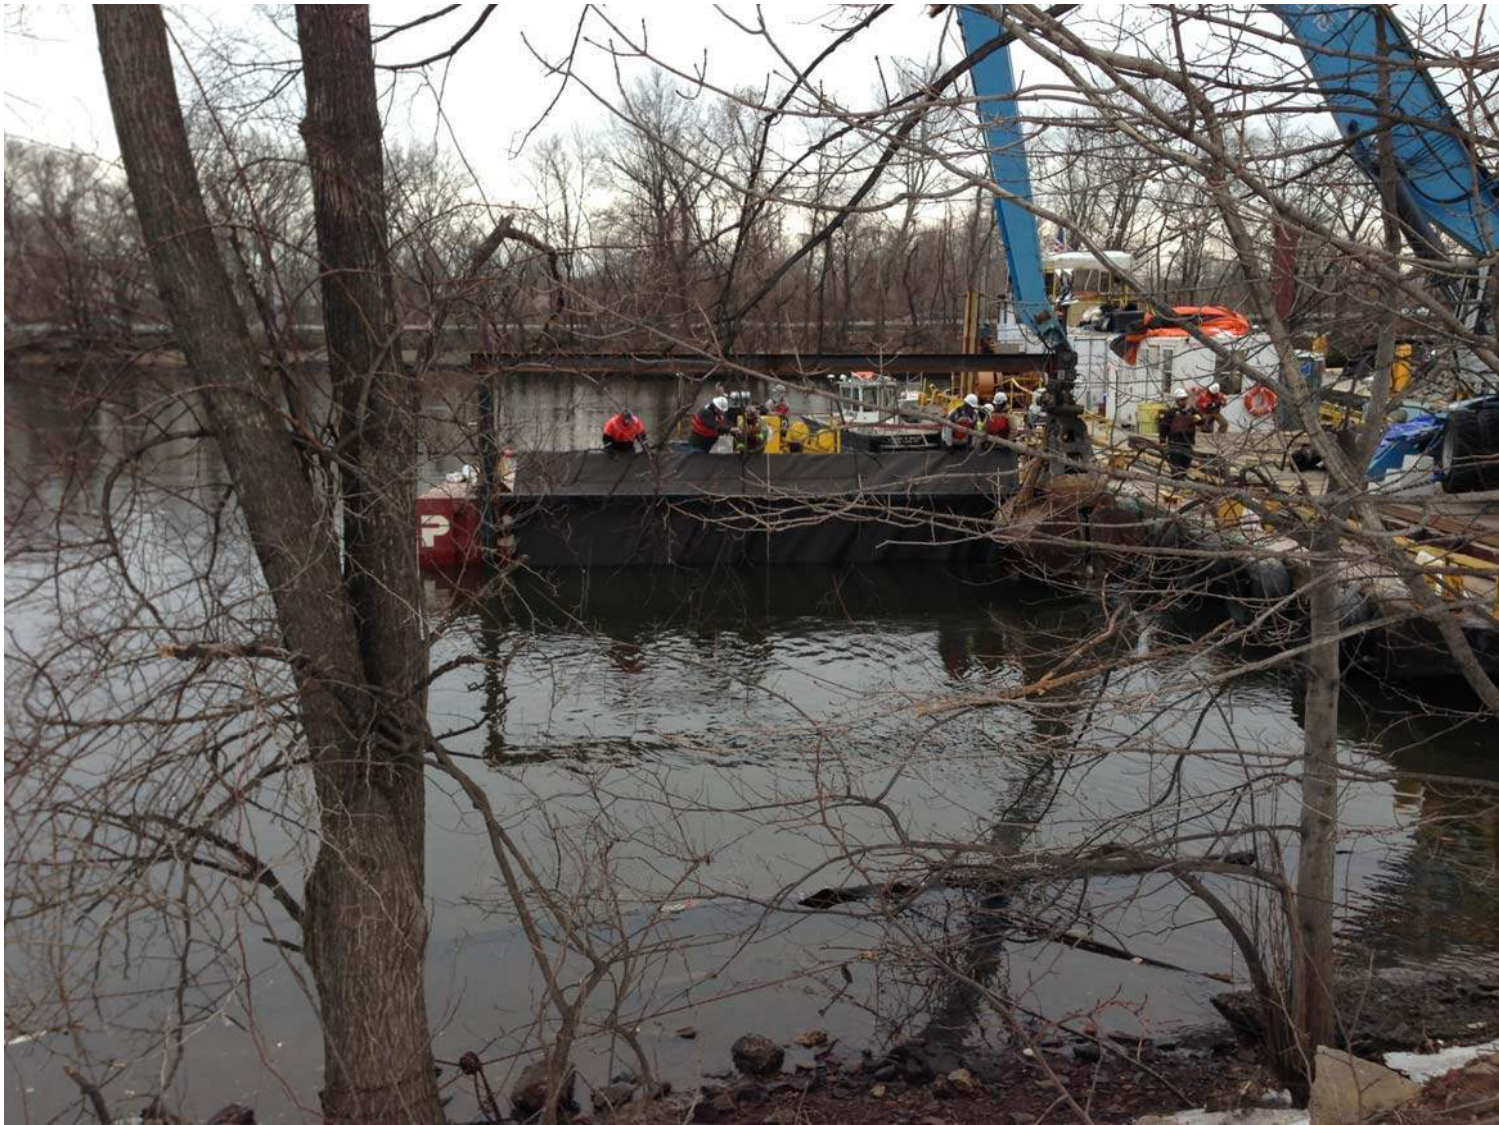
Installation of Rebar on Geotextile Fabric

GLDD attached the occasional length of rebar to the first geotextile panel installed today. The rebar was intended to prevent the fabric from folding with the current, and was generally successful.

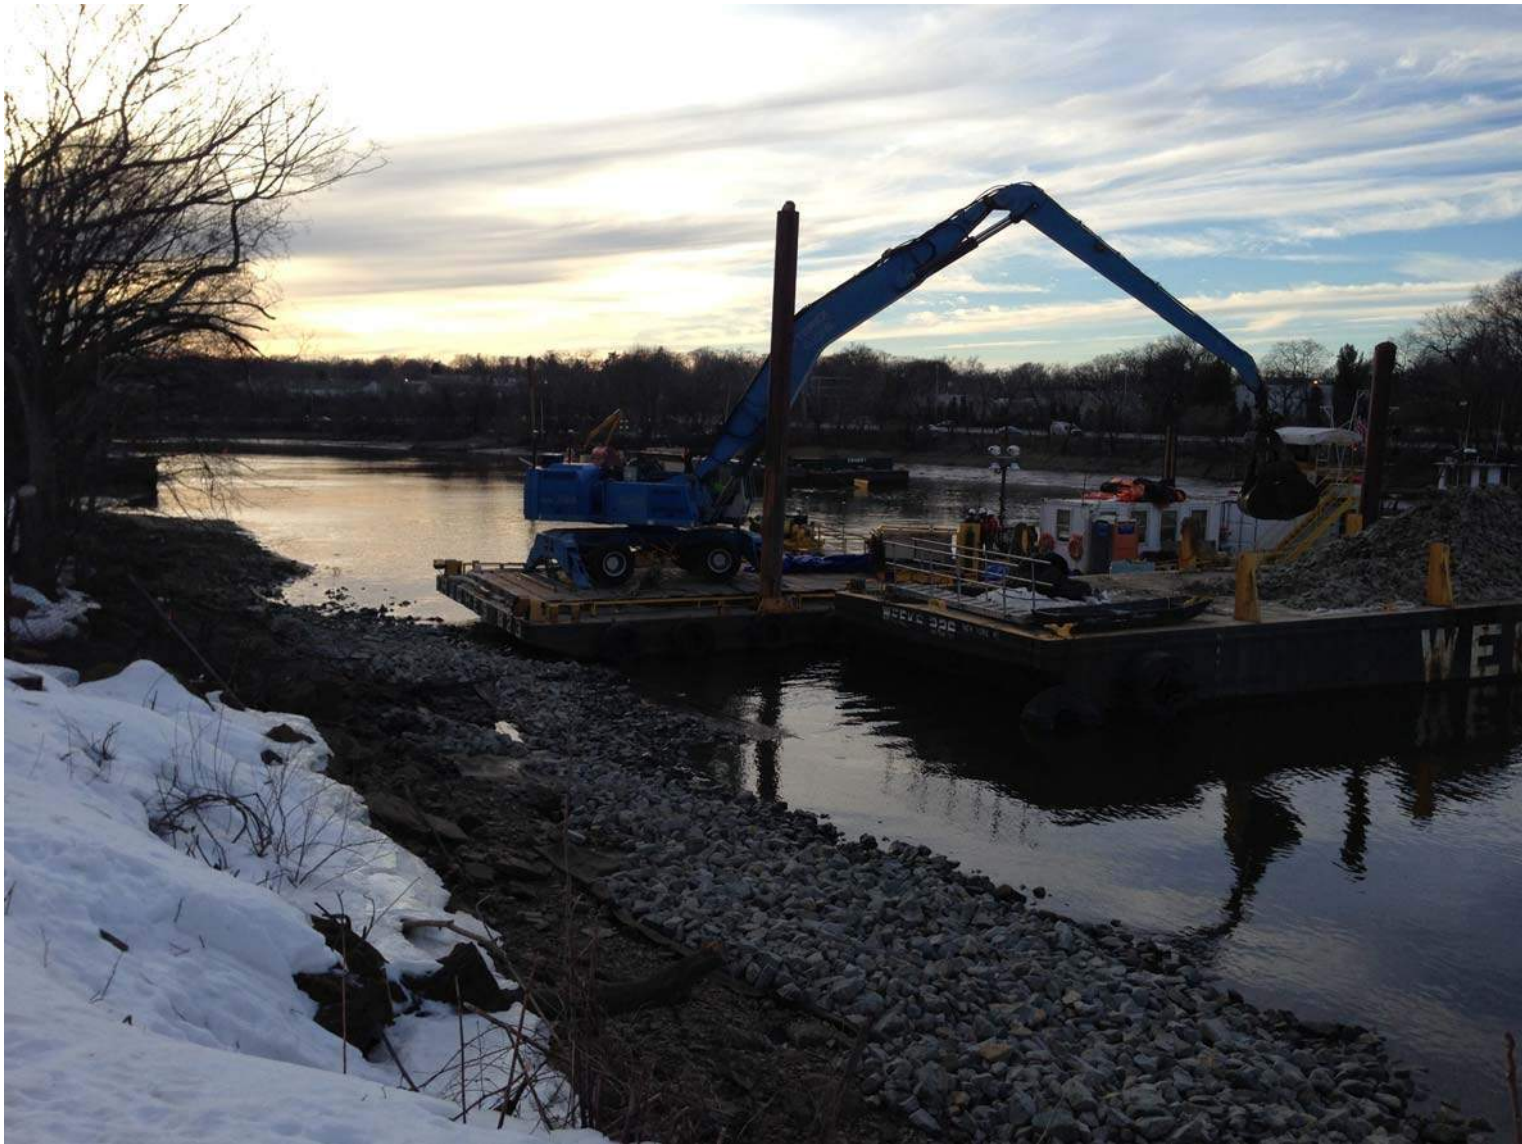
Finished Geotextile Panels from Shore

Three panels were installed today. They, as well as the three panels from Saturday, are shown in the above photograph.

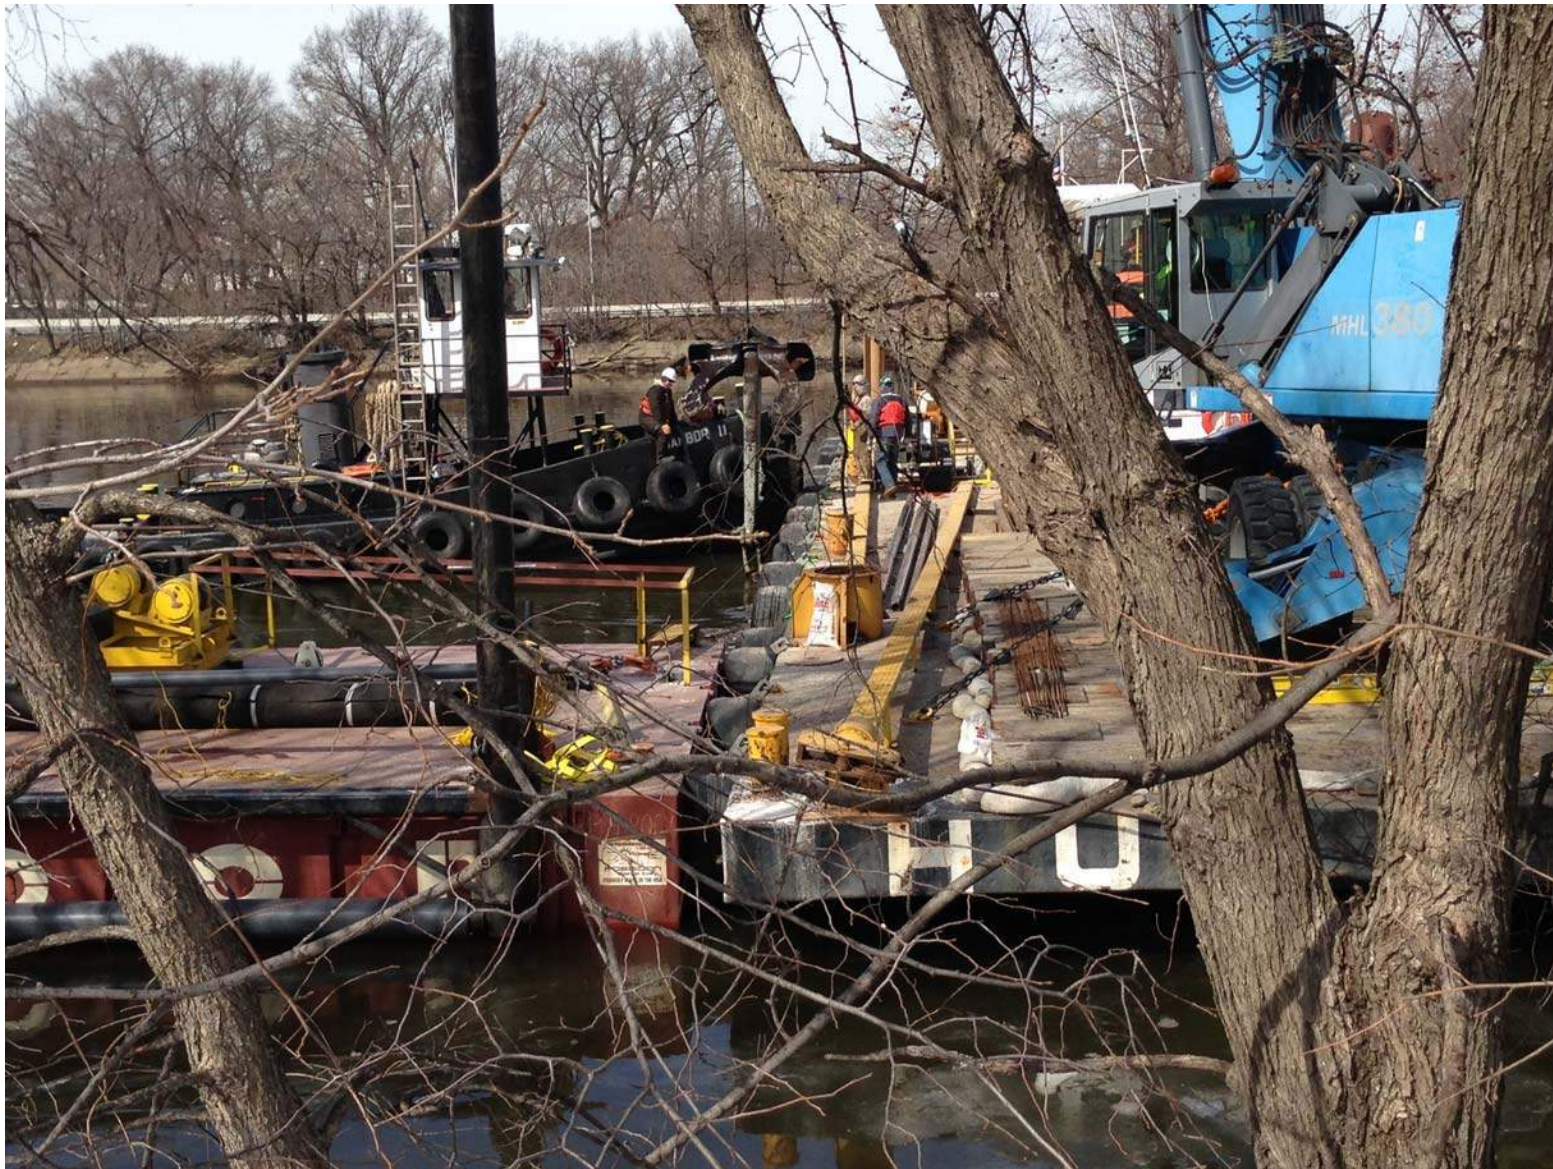
Resetting of Anchor

GLDD experienced a delay when it was noticed that an anchor had become dislodged. They pulled up the anchor and reset it.

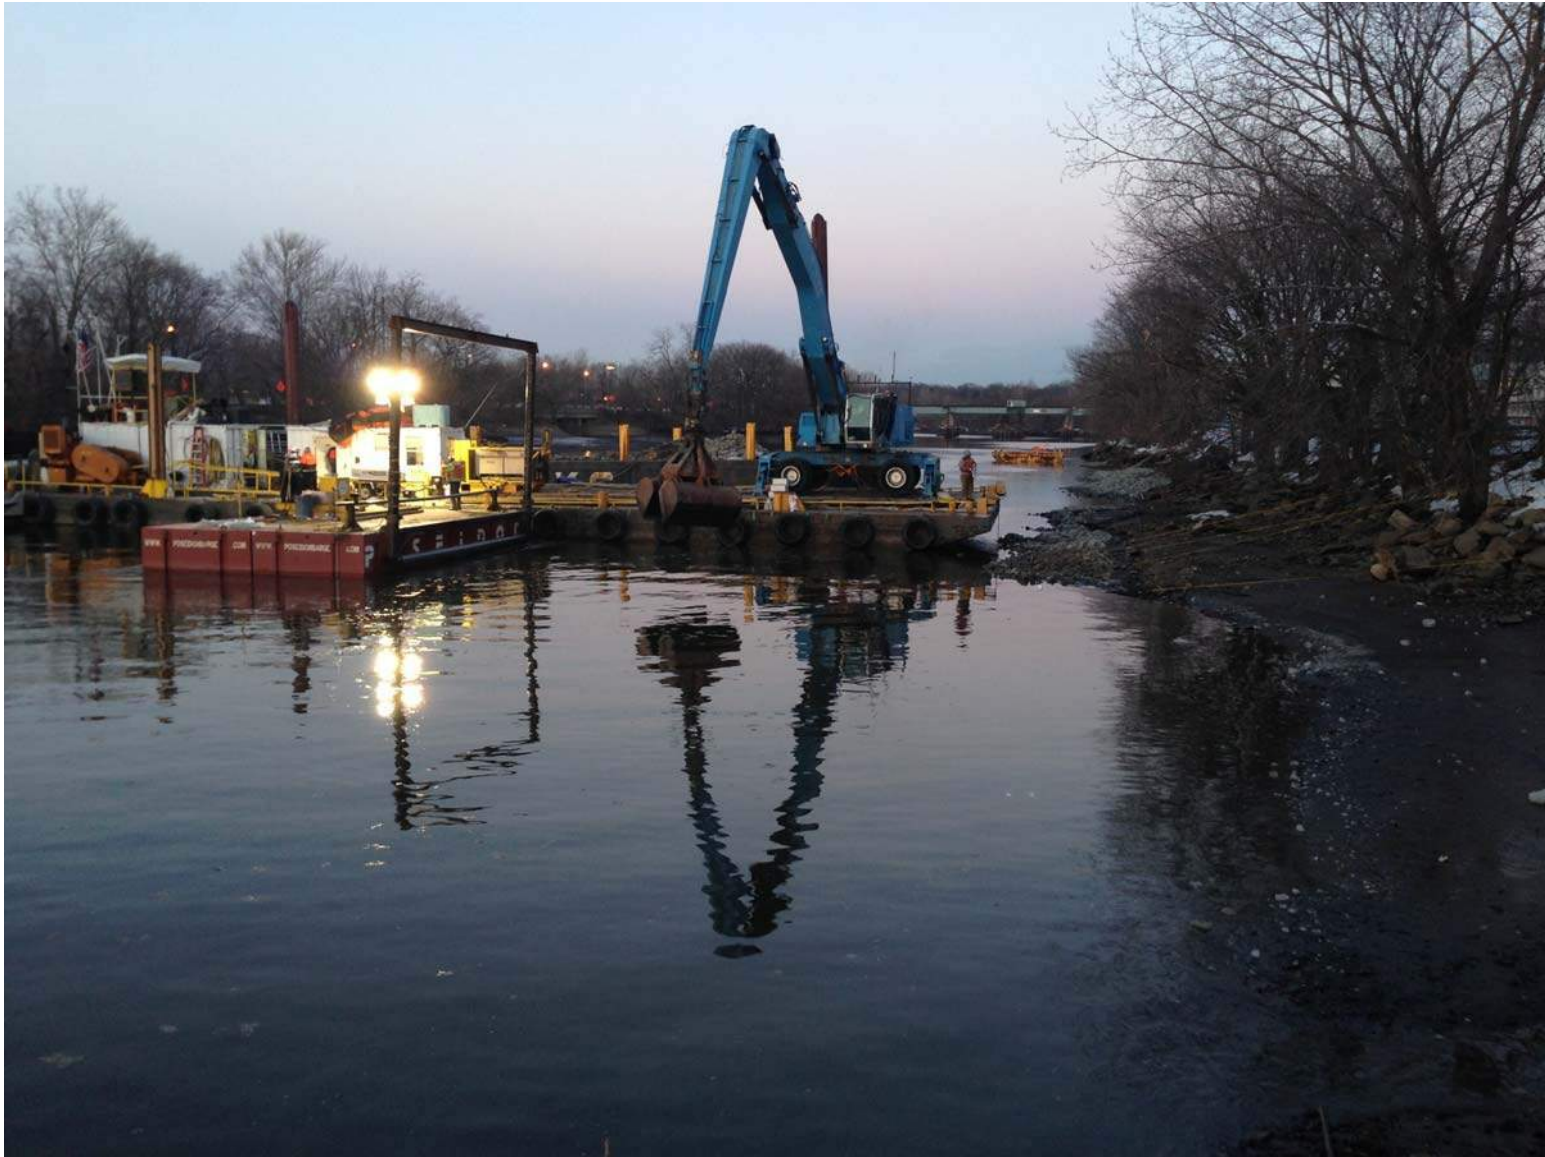
Progress by End of Day, March 5th, 2014

This photograph faces north and was taken from near the fire department boat launch. GLDD installed four panels today for a total of thirteen since beginning on February 26th.

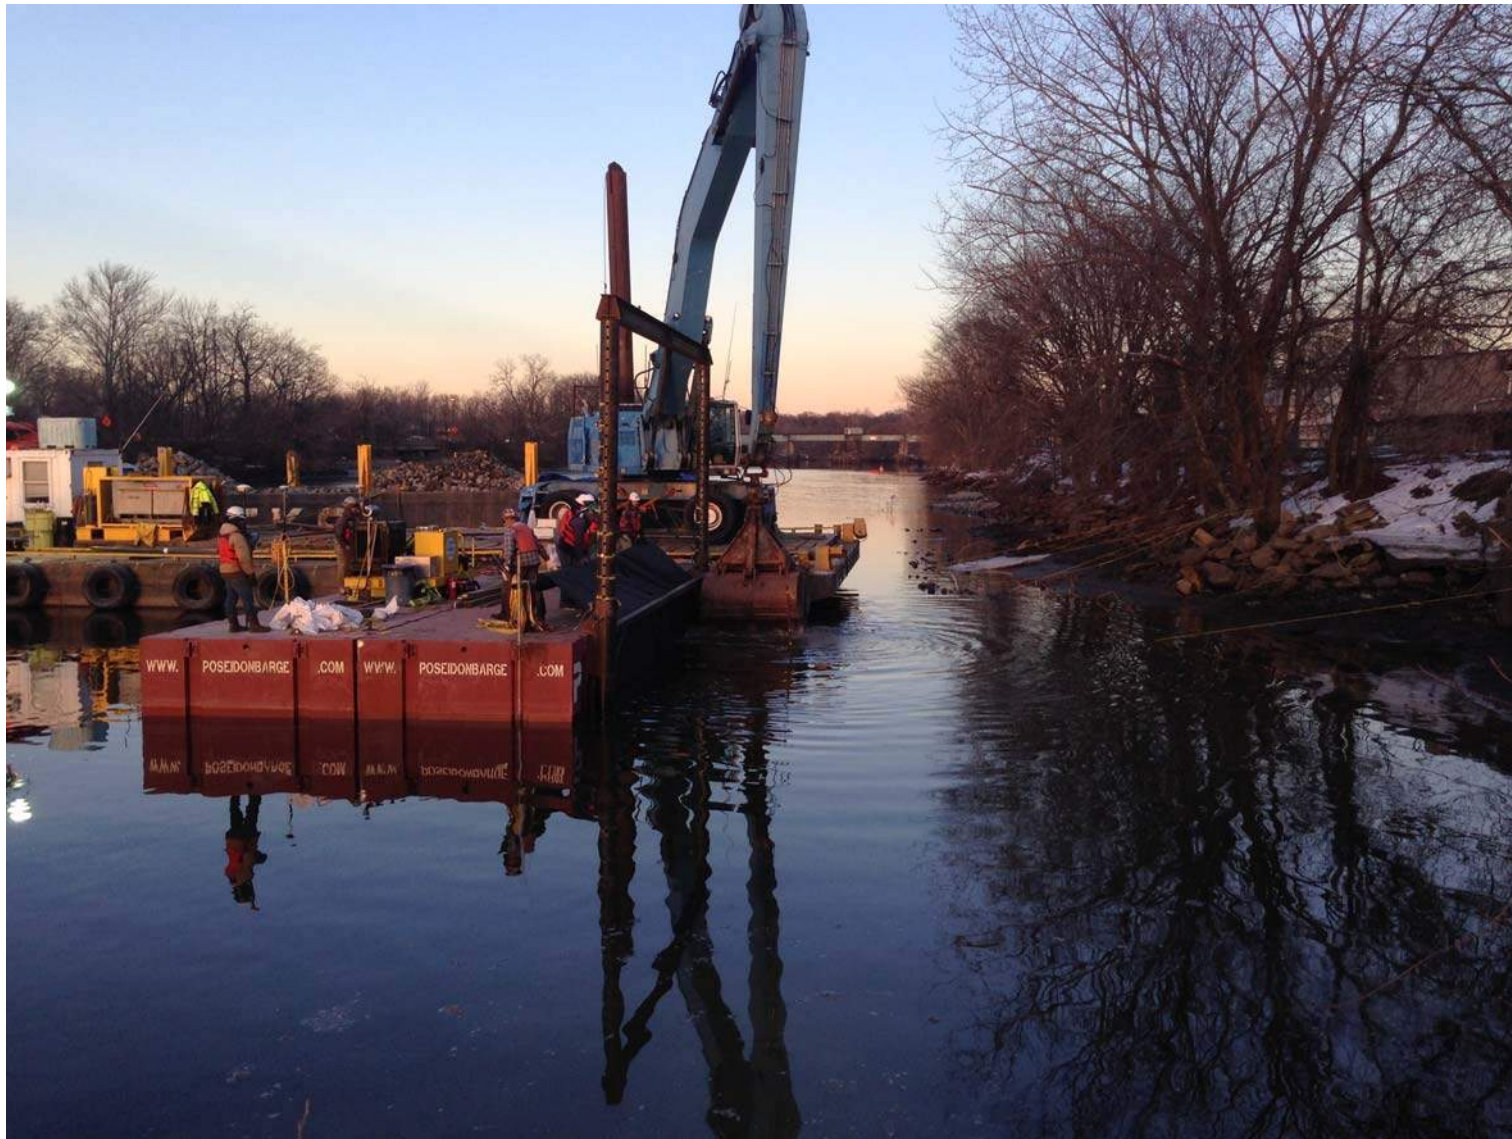
Preliminary Armor Stone Thickness Check

GLDD placed a rod in the water, on a piece of plywood for support. They used the mobile GPS device to survey the geotextile elevation at this location and will survey the armor stone elevation as a preliminary check of armor stone thickness. The rod is visible in front of the excavator bucket.

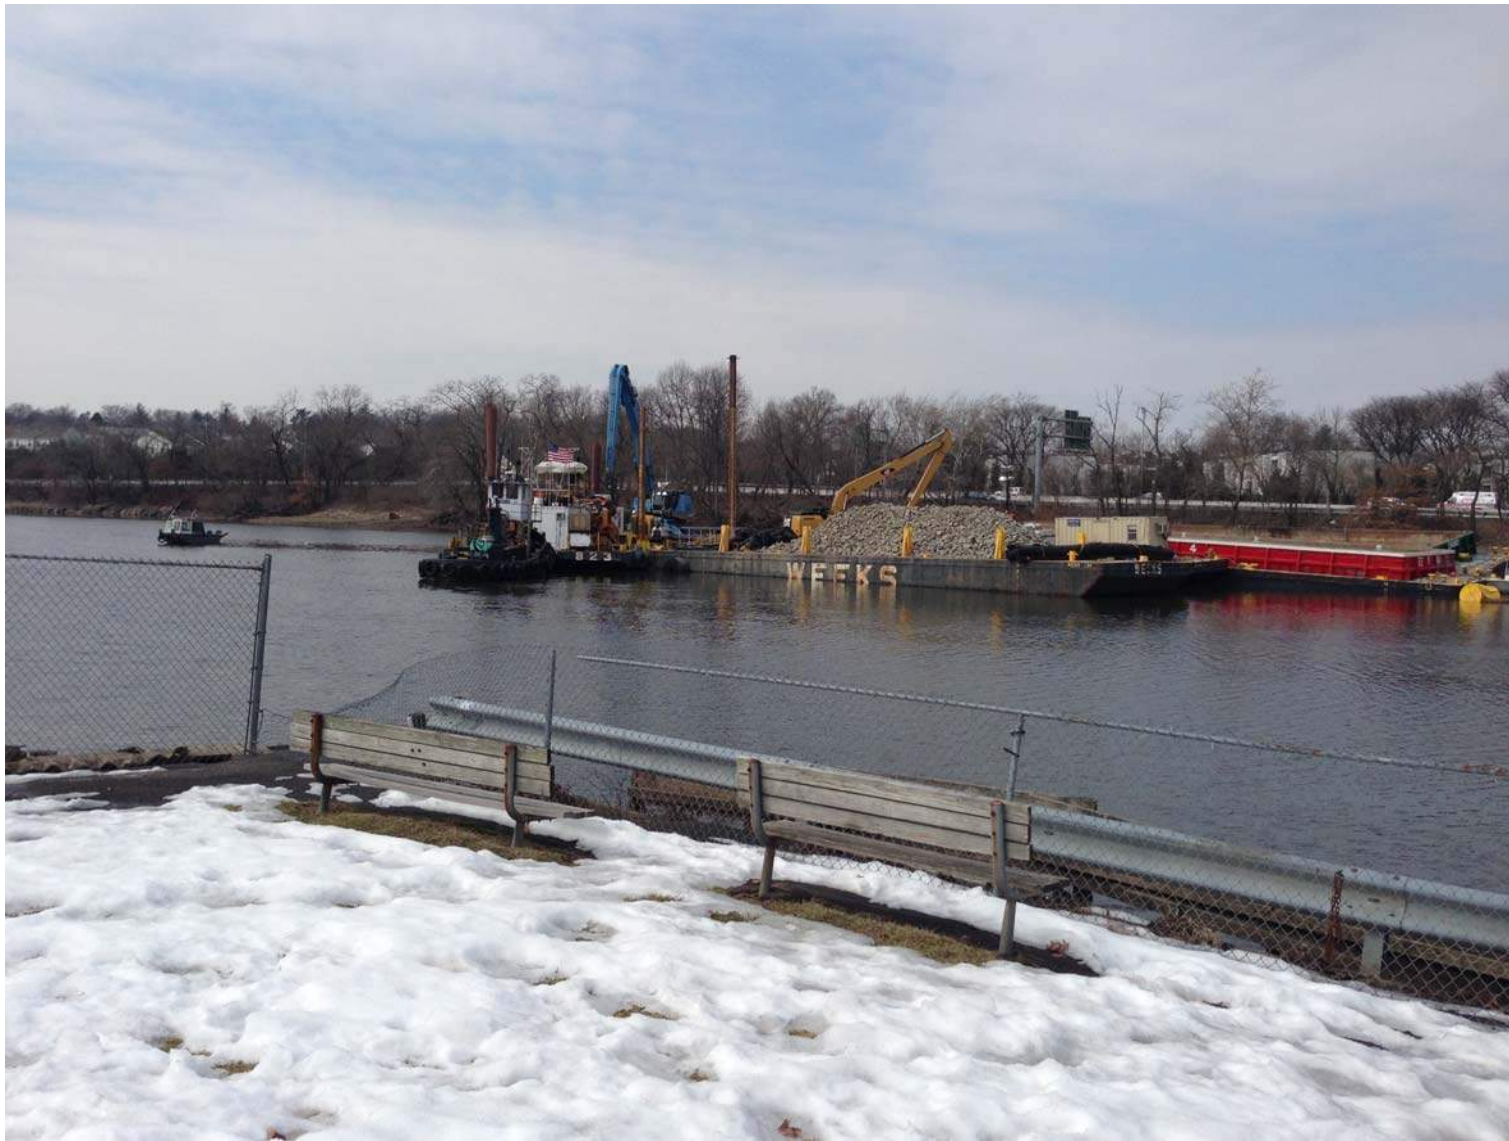
Barge and Scow Staging at RM 10.9

GLDD relocated the main barge and excavator to south of the No-Dredge Zone. They are pictured en route at around 1300. They hope to proceed with removing the unsuccessfully-placed armor stone and fabric from last December on Tuesday, March 11.

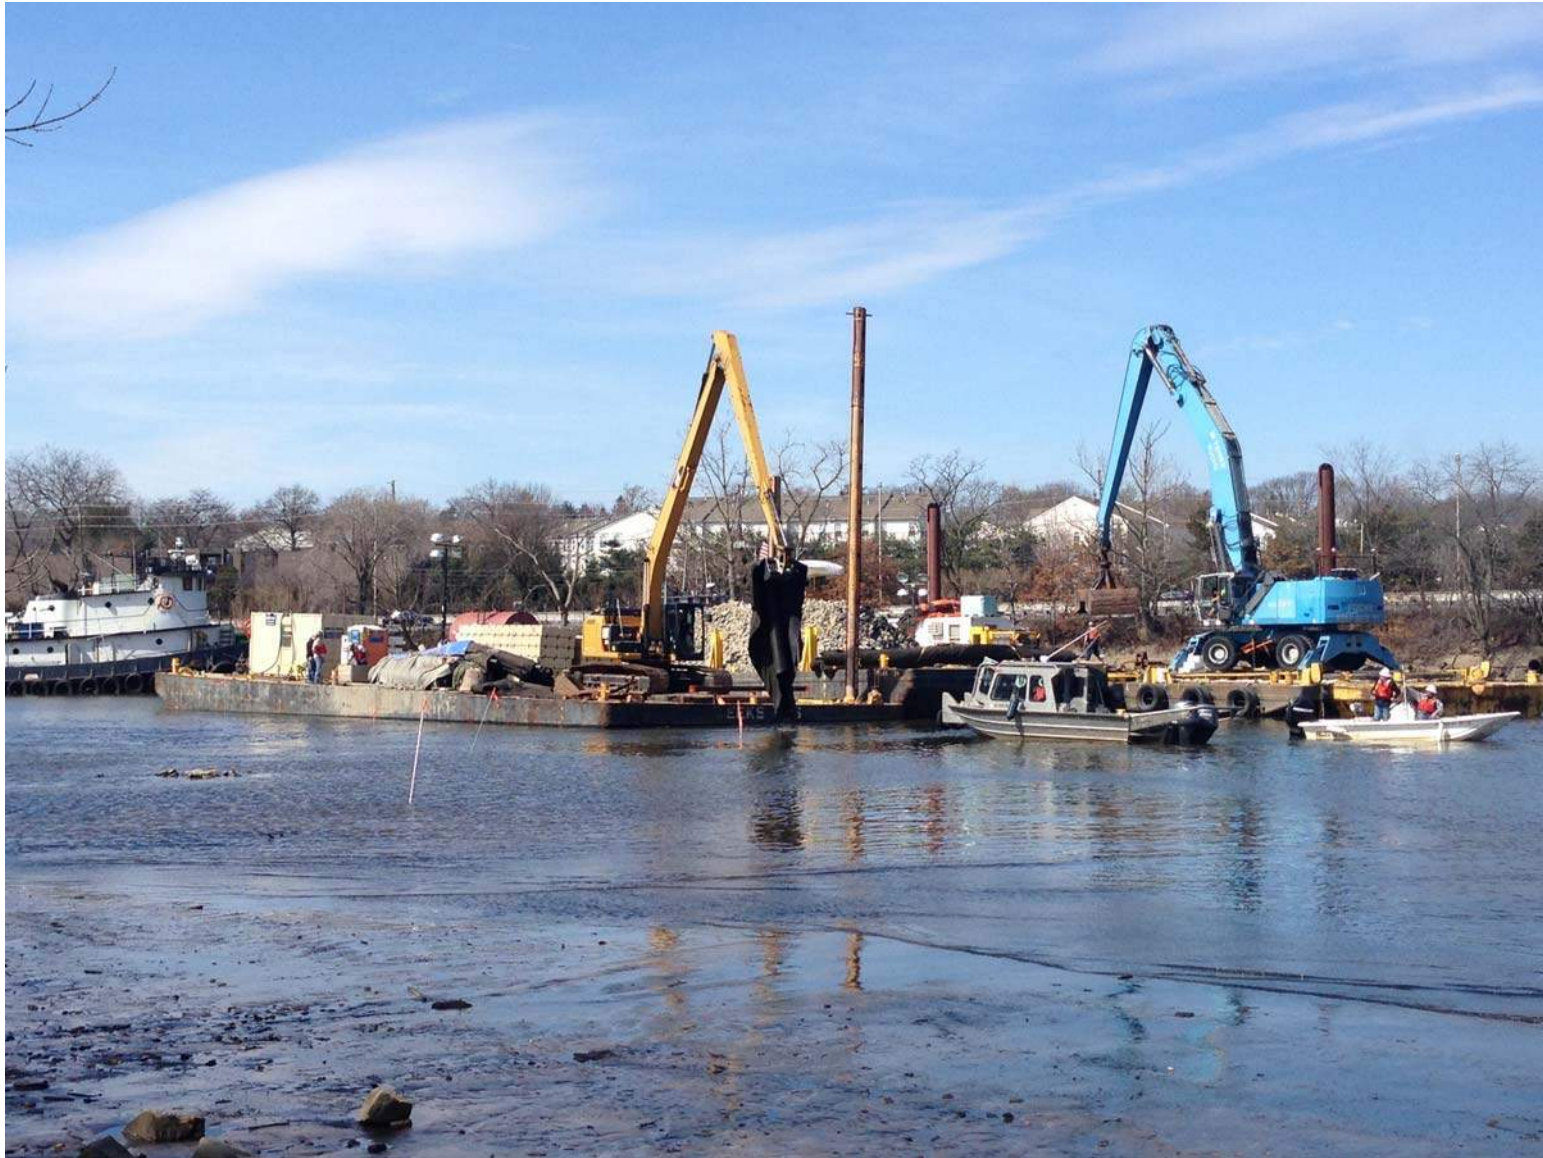
Geotextile Fabric Removal

The rock sifting rake removed multiple sections of geotextile from the area south of the No Dredge Zone where fabric/stone installation was first attempted in December 2013.

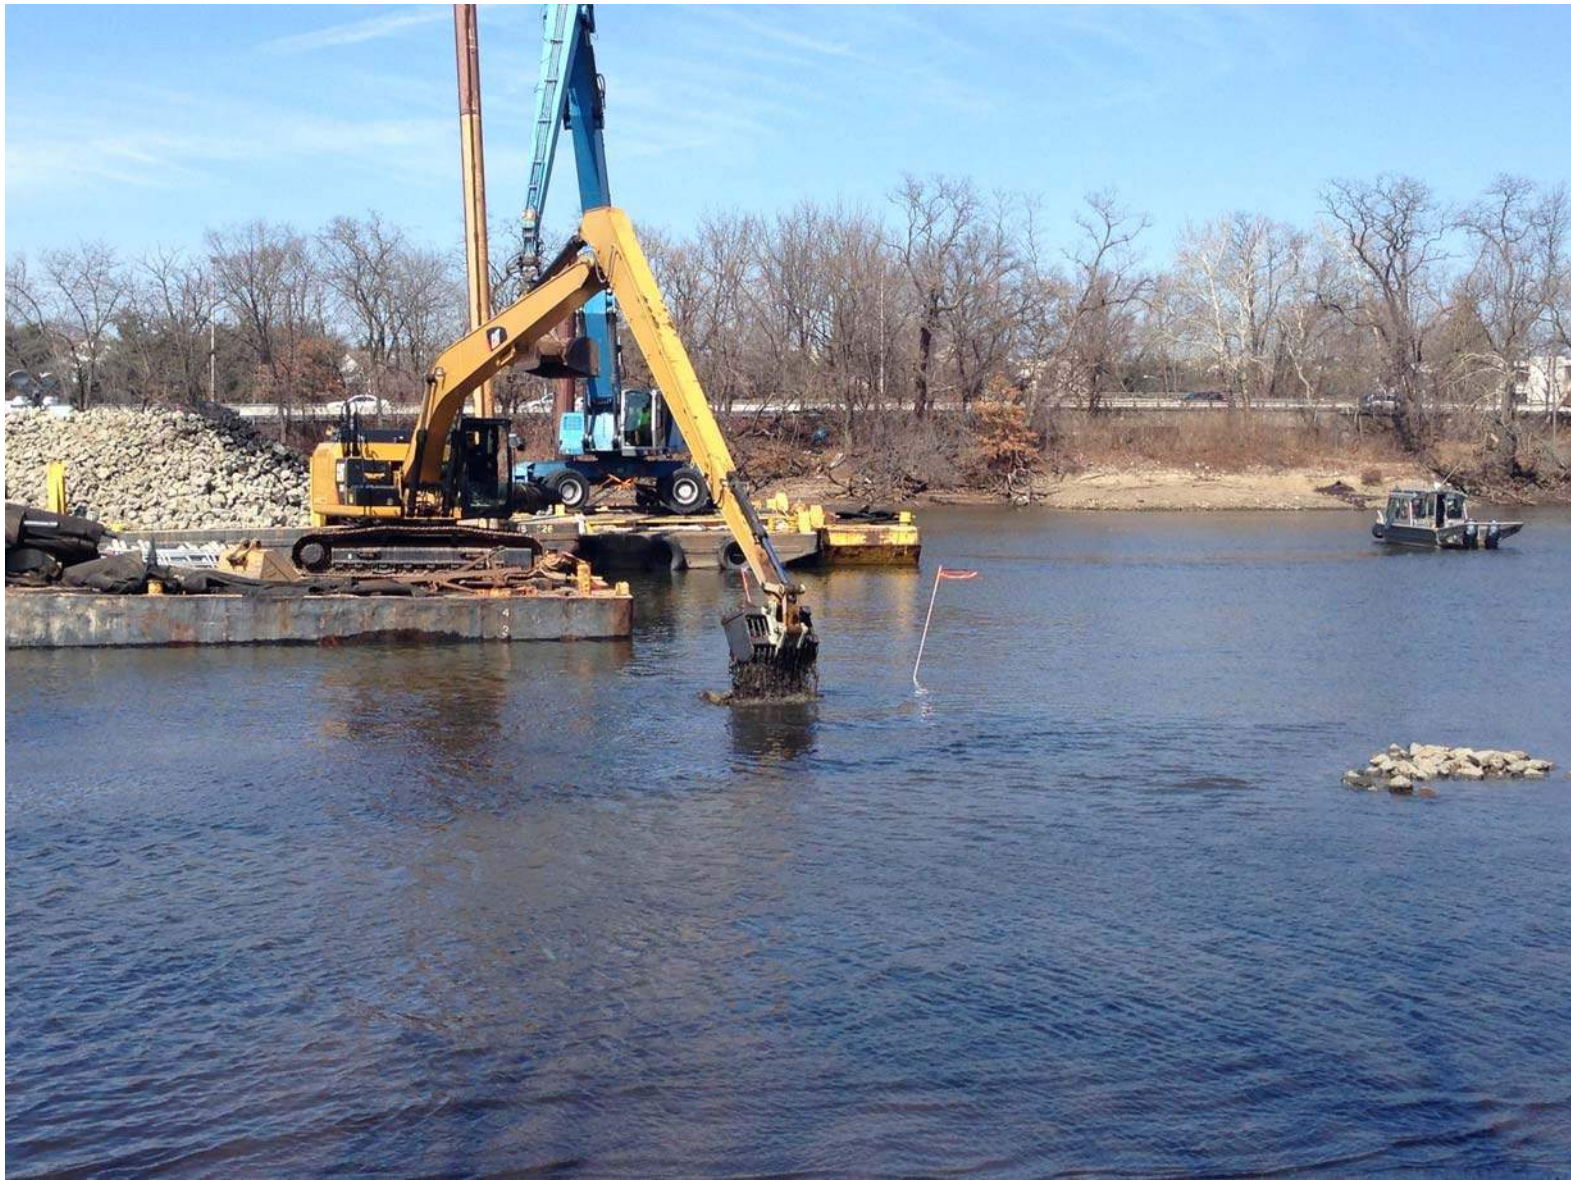
Resettling of Active Layer

After gathering a load of armor stone and active layer, the operator shook out the half-submerged bucket to allow the active layer to resettle.
